**Experimental Stabilization of a Looter Pit at the Goat Island "Campsite,"
a Prehistoric Archaeological Site,
in the Town of Red Hook, Dutchess County, New York**

Mary G. Burns, MS
Assistant Archaeologist, Hudsonia, Ltd.

July 31, 2002

New York State Department of Transportation
Project Identification # (PIN) 8756.31.321

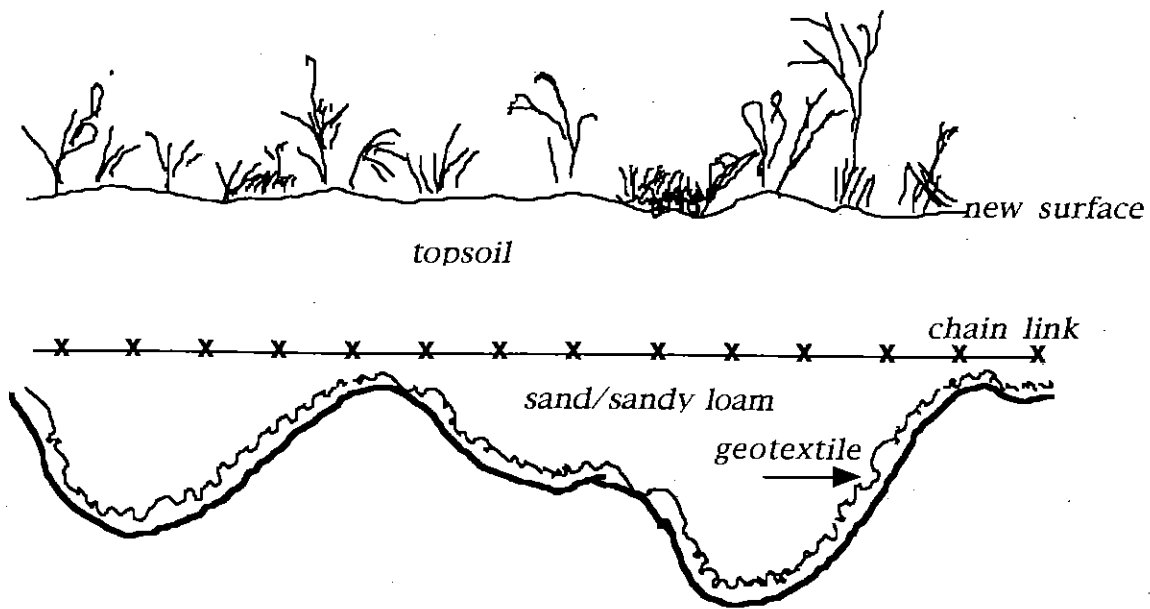
Geotextile would line the existing surface of the pits and mounds to mark the boundary.

Sand/sandy loam fill would level the pit and mound variations.

Chain link fencing would be laid over the sand above the pits to prevent digging and animal burrowing.

Topsoil would fill an area above the pits and mounds to create a new surface.

New surface would be topped with grasses, shrubs and poison ivy to lessen erosion and discourage looters.

Fig. 2. Proposal for soil burial. Redrawn from sketch by Dr. C. C. Mathewson (personal communication 1997). Adapted from: Burns 1997.

From my thesis research, I knew that the potential materials for protective site burial included sterile sand, geotextile (fine-mesh filter fabric), and chain link fencing (see Fig. 2). I also needed a watercraft to haul the materials to the island. Thanks to DEC and Bard College, the materials were donated. John Harrington, DEC Region 3 Operations Supervisor, supplied the geotextile and chain link fencing. Bard College's Buildings and Grounds Department agreed to supply as much road sand as needed.

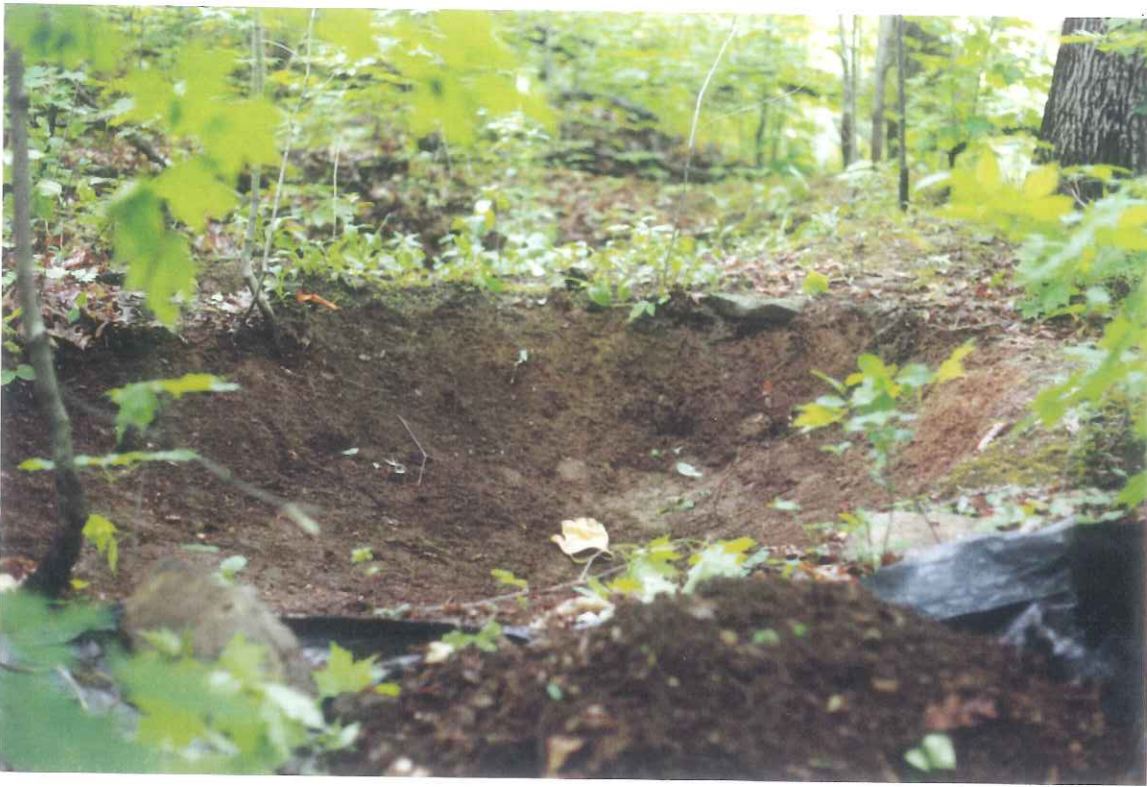
Fig. 3. The pit is ready for stabilization after the topsoil, leaf litter, and shallow-rooted flora were removed and stored. A glove, for scale, is in the bottom of the pit. Photo taken May 25, 2001, looking roughly east.

- * Clip the deep-rooted plants to a level even with the surfaces surrounding the pit (see Fig. 3).
- * Line the pit with geotextile and anchor it on the edges with rocks.

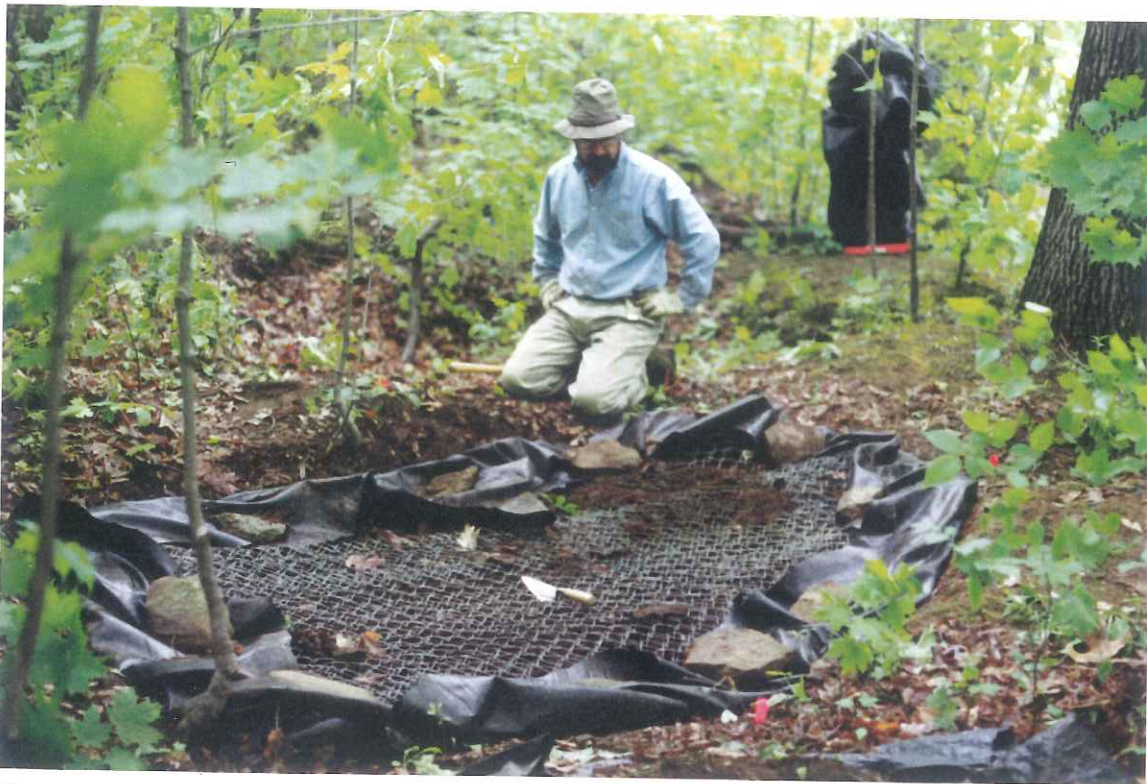
Fig. 4. To stabilize the pit, geotextile was placed as lining, then backdirt to fill, then chain link fencing with extra geotextile folded over its edge. Lindner looks on before backdirt is shoveled on top. Trowel in the pit points roughly north. Photo taken May 25, 2001.

- * Shovel backdirt onto the geotextile.
- * Place the chain link fence on top of the backdirt and overlap any extra geotextile around the edge of the fence and anchor it with stones (see Fig. 4).

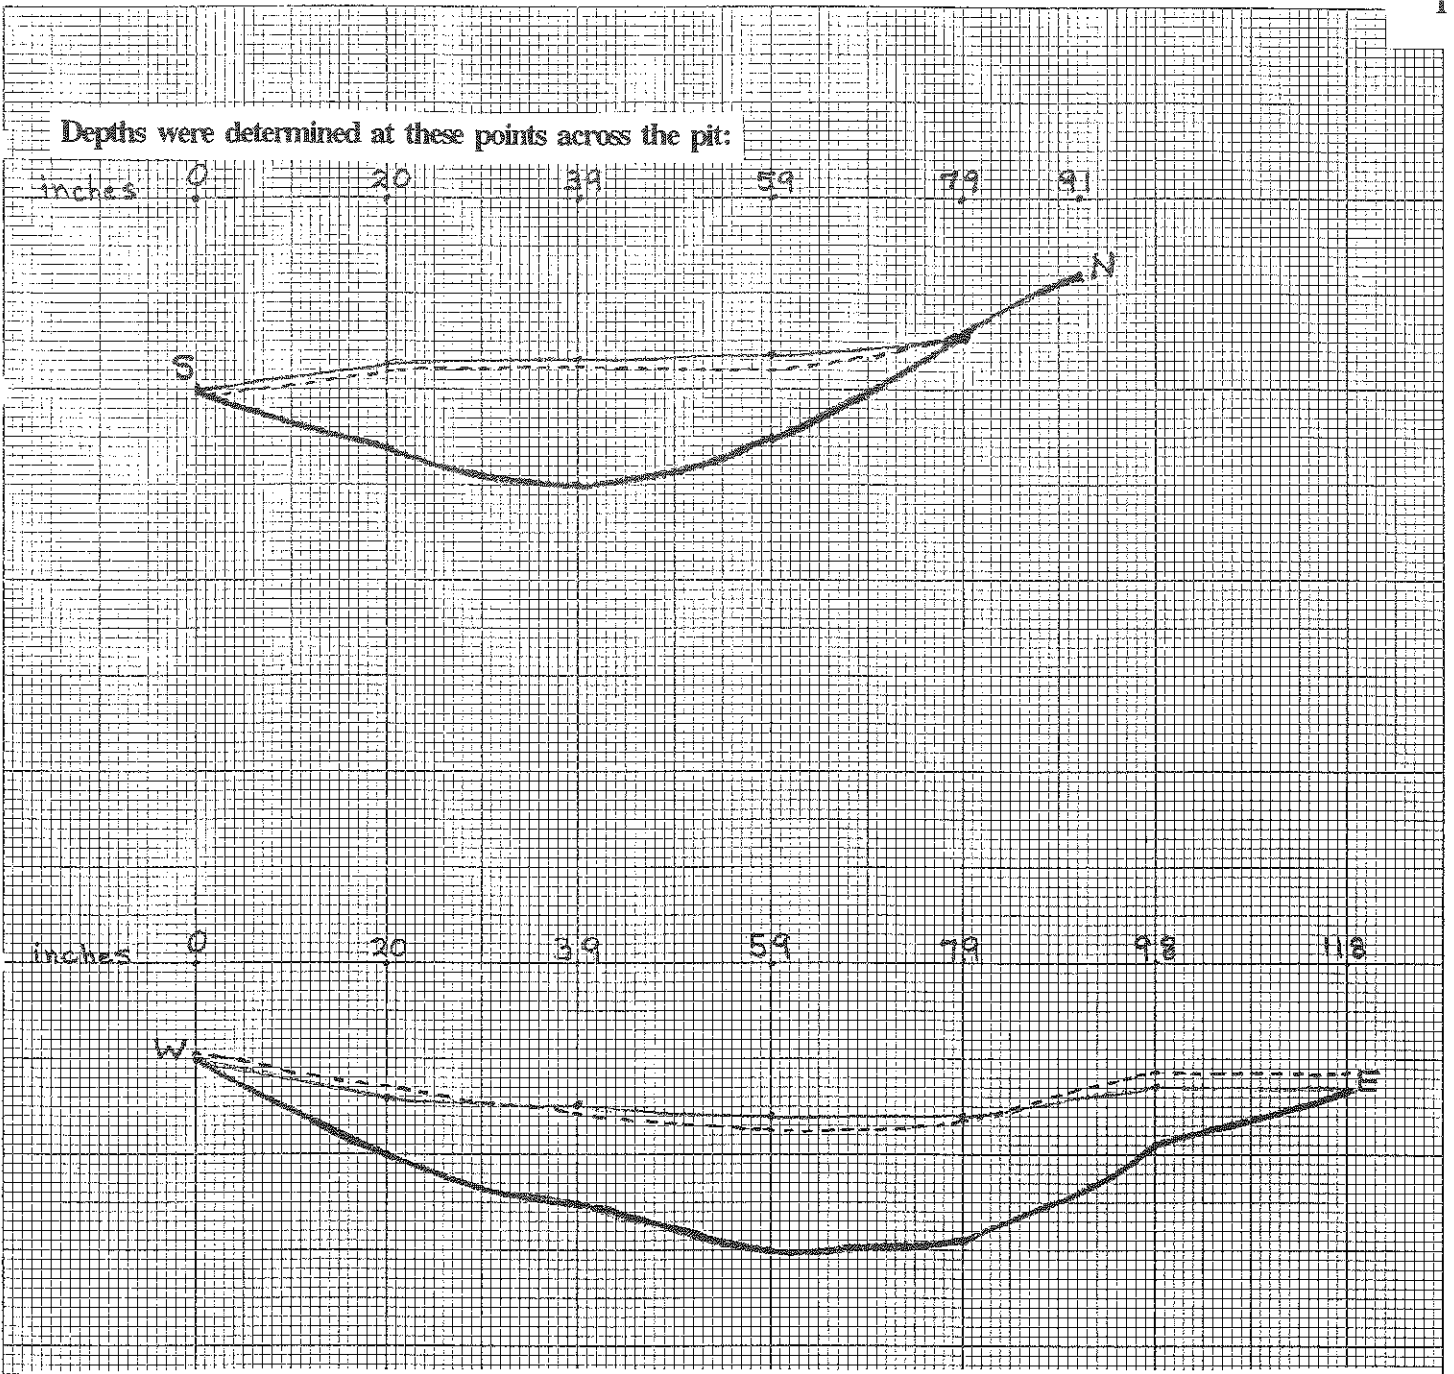
Depth measurements south to north and west to east across the stabilized pit show the fill shifted only slightly from May 2001 to June 2002 (see Fig. 5; Tables 1, 2). Several factors probably contributed to this. At measurement points 0, 20, 98, and 118 in. of the west to east profile, sand to cover exposed geotextile added 1.5 in. or less to the thickness of fill in those areas. At measurement points 0, 79, and 91 in. of the south to north profile, there was no change. At all the other measurement points of the south to north profile, and at 39, 59, and 79 in. of the west to east profile, the soil used to fill the pit has settled and compacted over time causing a slight decrease in thickness of fill; at 59 in. west to east and north to south, the subsidence is 1.5 in., but nowhere is the decrease in thickness more than that. Beyond these considerations, Lindner and I recognize that in the process of taking the measurements three times -- May and August 2001, and June 2002 -- we developed a more precise way of measuring; this, too, could account for the small discrepancies in thickness.

Fig. 5. Top: Profile of pit from SOUTH to NORTH

Bottom: Profile of pit from WEST to EAST

- = fill, measured June 18, 2002
- = original fill, measured May 25, 2001
- = looters' hole

- * Cover the fencing with the topsoil, leaf litter, and flora that had been stored.
- * Remeasure depths across the pit from south to north and from west to east (see Fig. 5; Tables 1, 2).

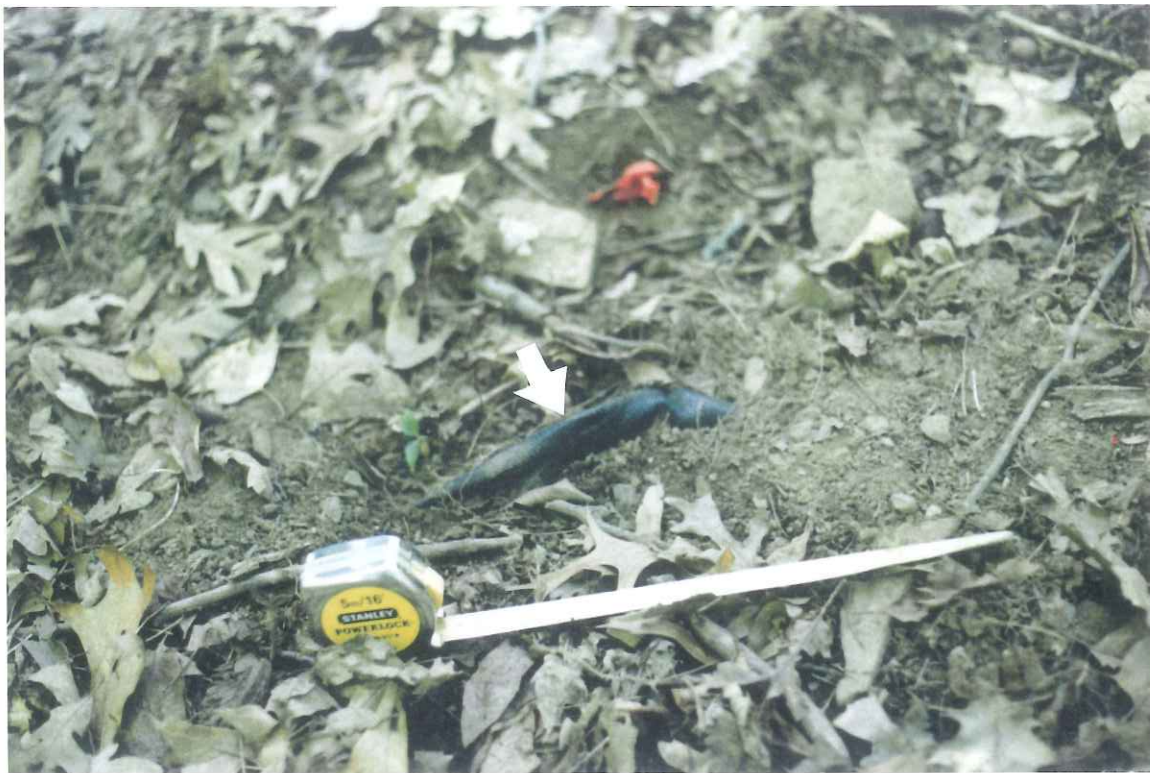
Monitoring shows the stabilization work has remained basically intact during the 13 months since it was performed. The pit is blending in well with its surroundings and has become vegetated with forbs common on the island: Dutchman's Breeches (*Dicentra cucullaria*) and Garlic Mustard (*Alliaria petiolata*) were growing there when I monitored the site on May 11, 2002. The only problem encountered was that the geotextile fabric became exposed in several areas where it overlapped the chain link fence at the pit's edge (see Figs. 6, 7; Table 3); the exposures were caused naturally, by erosion and, once, possibly by pulling (see Report #2, Aug. 29, 2001). During all visits, except in Dec. 2001, I found this had happened and each time I covered the exposed fabric with all-purpose sand, which I had brought by canoe, and leaves.

Fig. 6. At the white arrow is an example of an exposed piece of geotextile, approx. 8 in. long (tape is set at approx. 1 ft.) and located on the west edge of the stabilized pit. Photo taken Aug. 6, 2001.

Our goal was to test a stabilization method on a looter pit at the Campsite on Goat Island in an effort to determine whether the method would deter further illegal digging of the pit as well as stop erosion. The strategy was successful. The only problem is that the all-purpose sand, used to cover up areas where the geotextile became exposed, continues to erode off of the geotextile, although not as badly as the first time I noticed it on Aug. 5, 2001. Perhaps in the future a finer sterile soil (silt with clay) could be mixed with the sand to make it hold better.

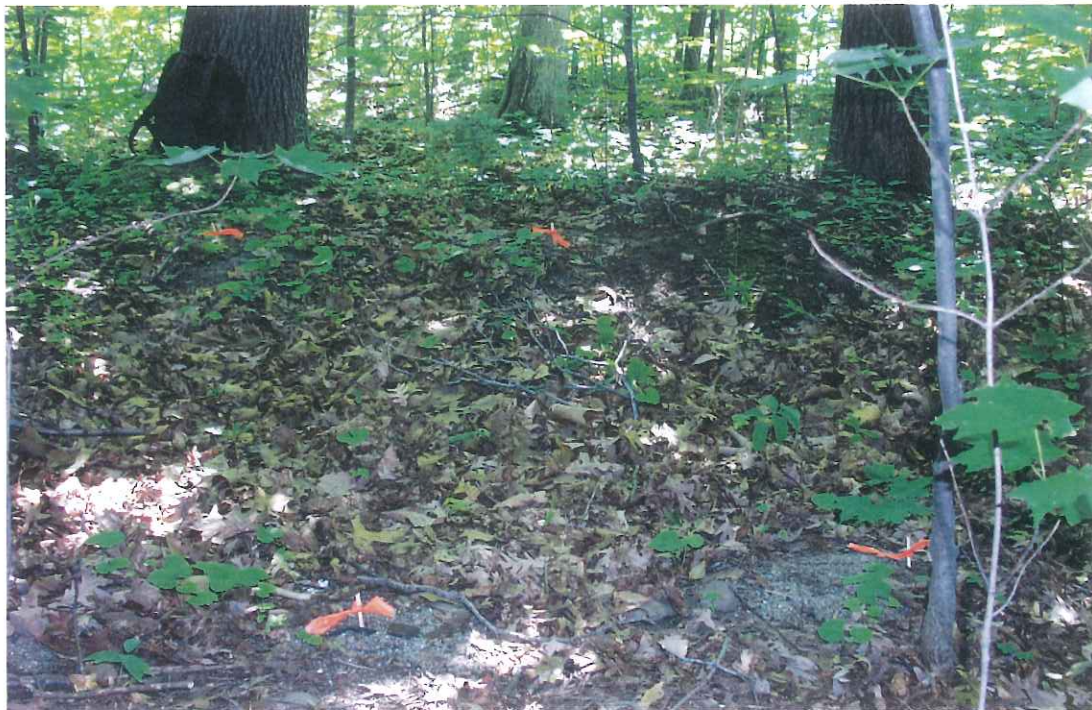
Fig. 7. Orange flag tape in 4 places marks where the geotextile was exposed. Photo taken June 18, 2002, looking roughly east.

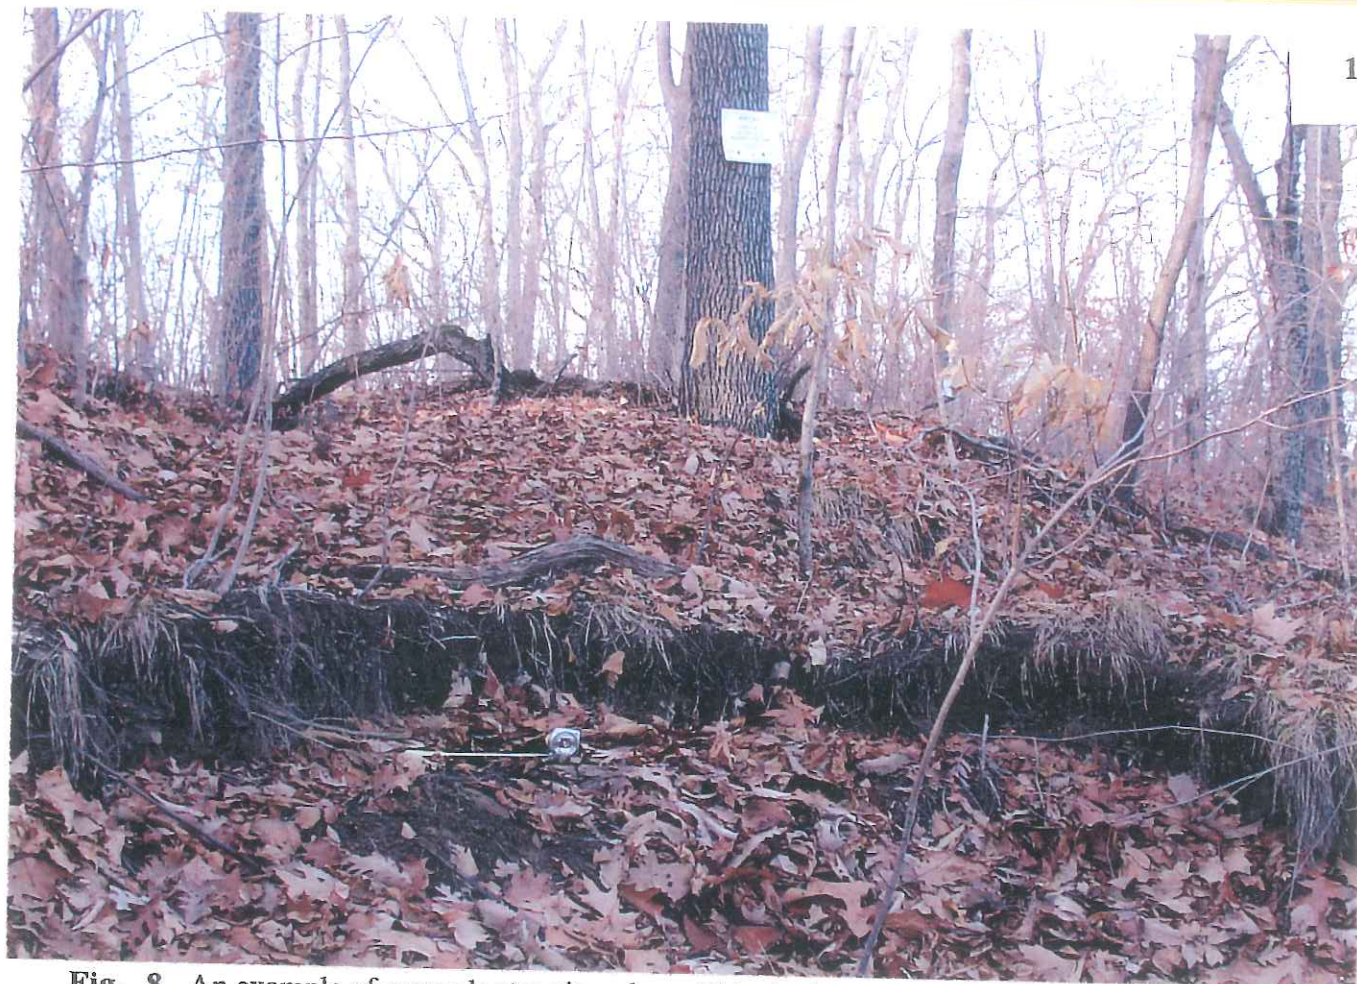
Looting continues at the Campsite (see Fig. 8). In Reports #2 and 3, I included notes and photos of the newer areas of disturbance. Of equal concern are the older pits that continue to weather and erode; these actions cause damage to intact soils. As illustration, Figure 9 of this report is a photo of a particularly large, older pit next to the stabilized pit that is the subject of this report.

Fig. 8. An example of a new looter pit -- dug within the last two years -- is approx. 200 ft. south and east of the stabilized pit. Note the tree with a sign which reads "DON'T DIG. REMOVING ARTIFACTS IS AGAINST THE LAW." Photo taken Dec. 16, 2001, looking roughly northwest.

1. mapping the approximately 200 looter pits and mounds in order to create a complete baseline; right now, I am probably the only person who can recognize when a pit is recent.
2. burying the entire Campsite to save it for the future when archaeological methods and research questions will be different.
3. more patrolling.

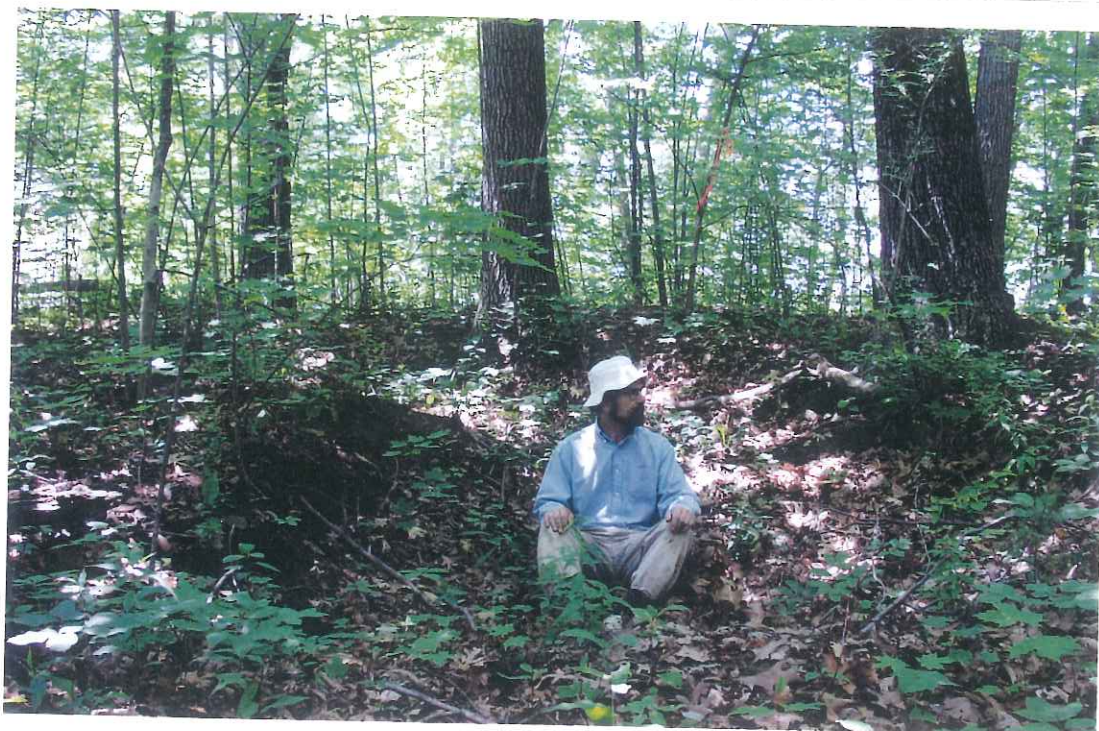
Fig. 9. An example of a large, older pit. C. Lindner sits in the pit to show scale; to indicate location, the red flag tape hanging in a tree above Lindner's left shoulder is near the east end of the stabilized pit. Photo taken June 18, 2002, looking roughly southwest.

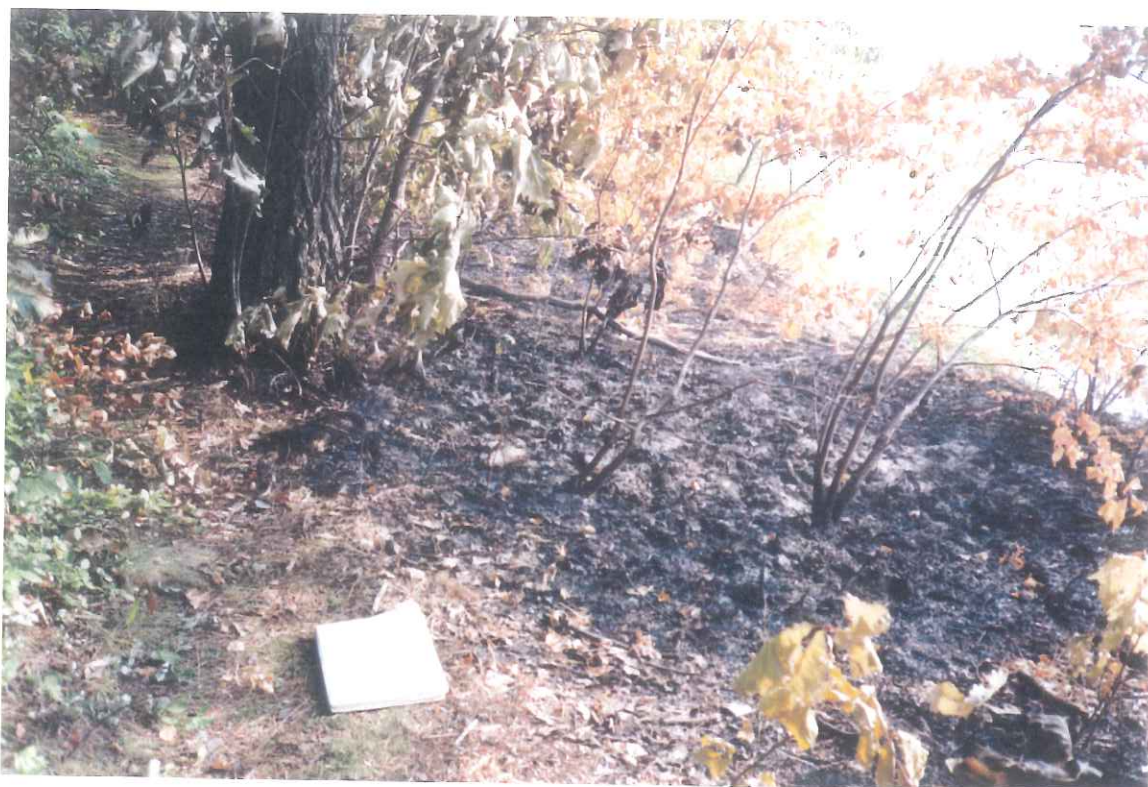
Also of concern is the continuing evidence of human-caused fires on the island. In a memo dated August 9, 2001 to Vissering, I wrote my observations of fire damage to the west side of the island on a reconnaissance I made there three days earlier; I also sent her photos of the damage (see Fig. 10). During the June 18, 2002 trip to monitor the site, Lindner and I walked down toward the south end of the island and came upon a fire-ring and a large, crudely-constructed bench (see Fig. 11). I alerted Blair and, on June 25, 2002, gave her a hand-drawn map and photos of the bench and fire-ring. In a phone conversation on July 3, 2002, Blair informed me that DEC Assistant Forest Ranger Don Miller had removed the bench and ring.

Fig. 10. Fire damage to the west side of the island. A notebook marks a well-worn path. Photo taken Aug. 6, 2001, looking roughly southwest.

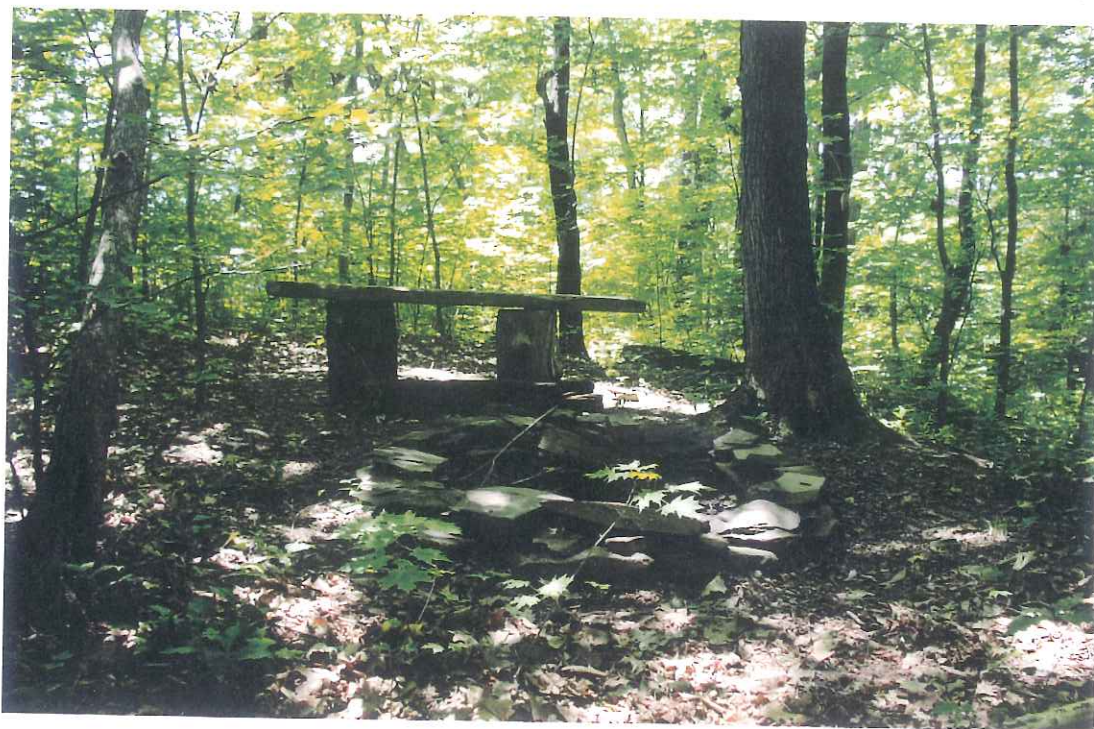
Fig. 11. A fire ring in front of a bench located south of the "Campsite" archaeological site. Photo taken June 18, 2002, looking roughly south.
